BoRit Asbestos NPL Site Hurricane Irene Situation Report – August 28, 2011

GENERAL UPDATE

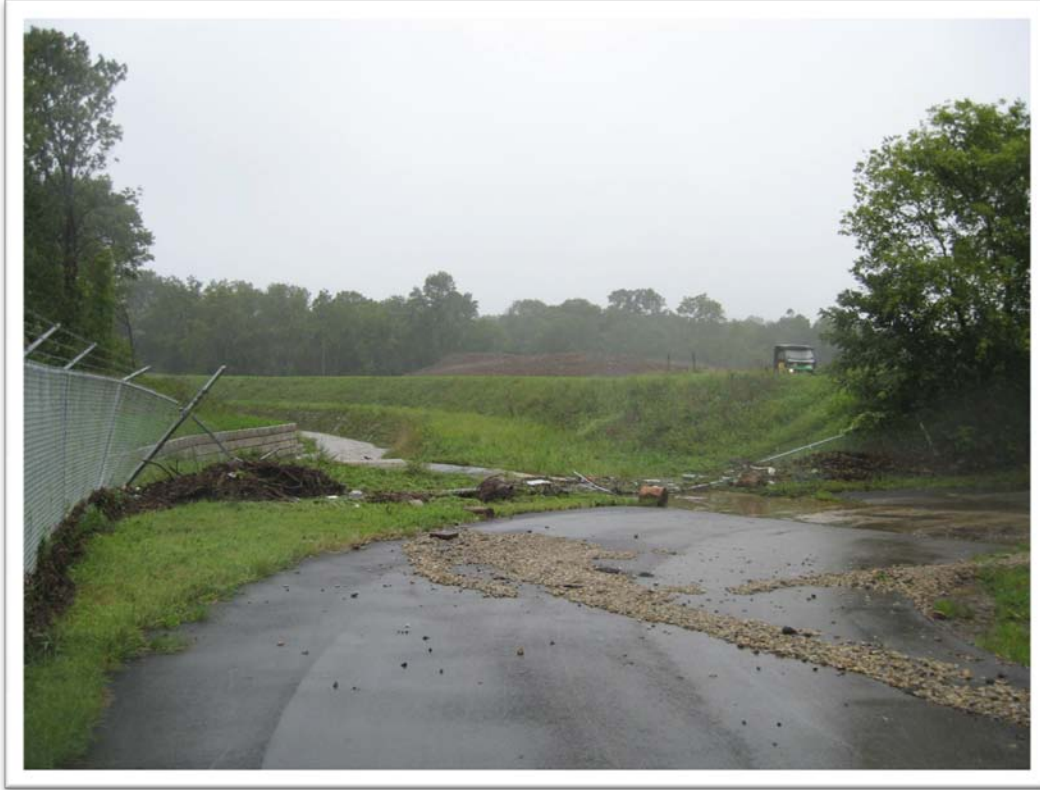
South gate (at the park) by Rose Valley Creek

As mentioned above, the south gate (and a section of the fence) by Rose Valley Creek will have to be replaced. The stream banks looked OK, no erosion problems noted.

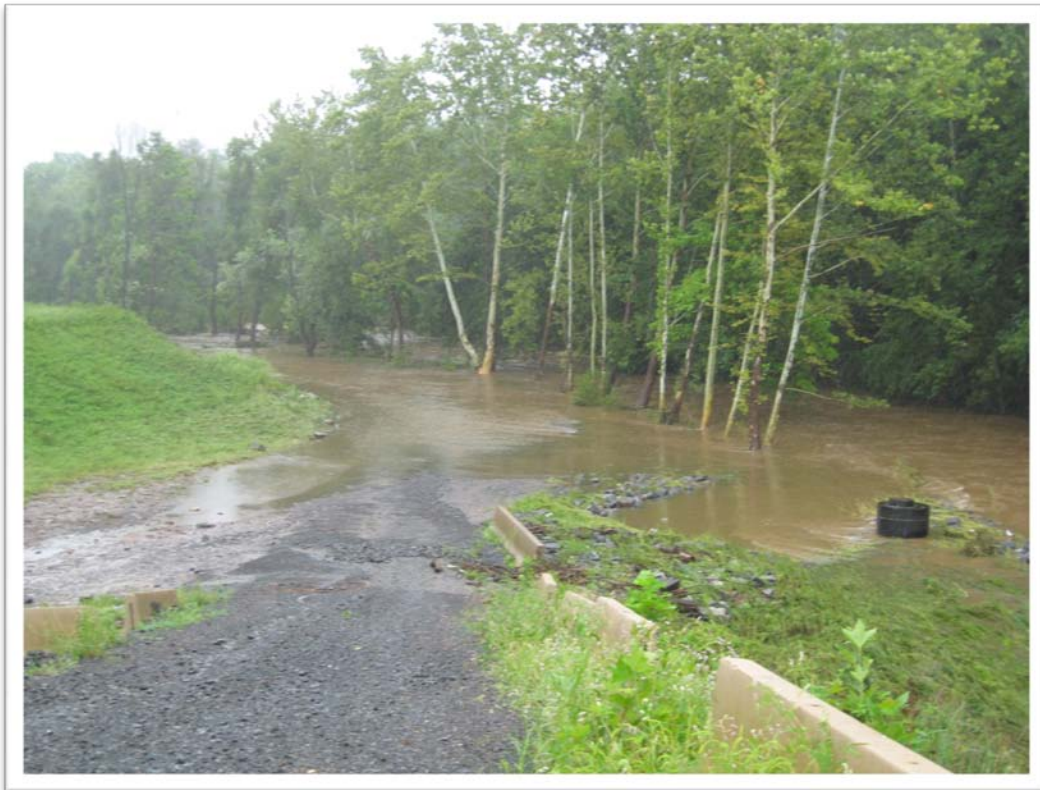
Confluence of Rose Valley and Wissahickon Creeks

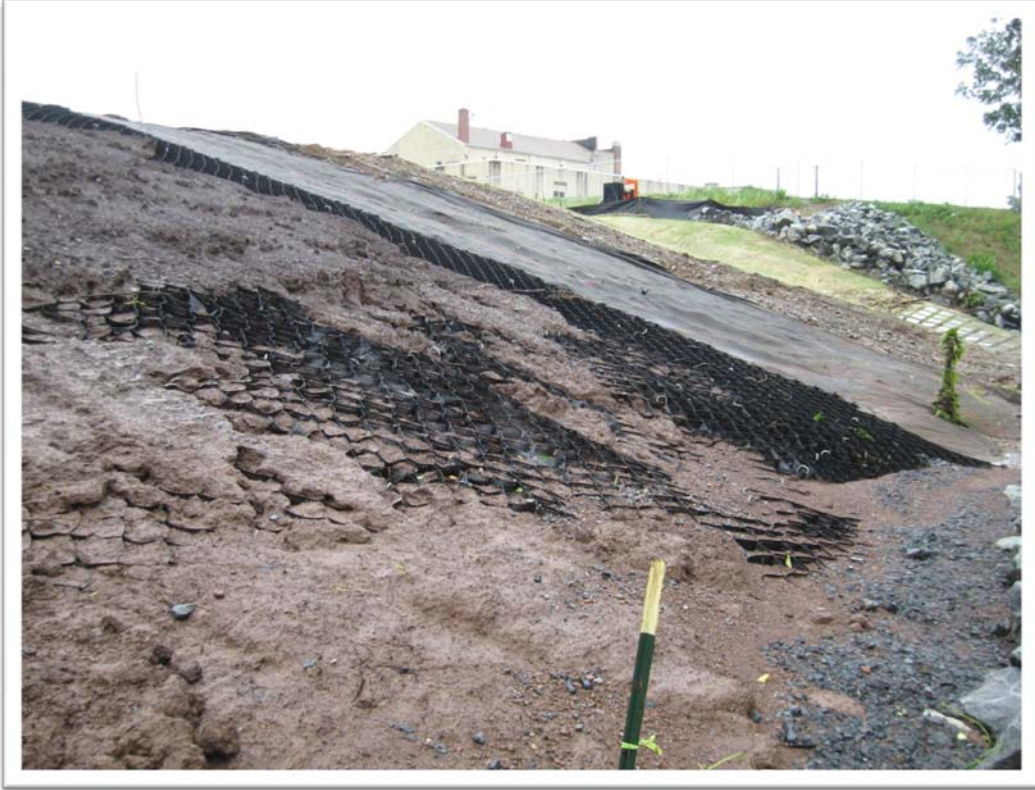
The water got as high as 3 to 4 feet over the riprap line. The area with the ArmorMax (green mat) seems to be intact; however, along the geocell area that had been recently infilled, some of the topsoil washed out.

Geocells – Phase V Slope

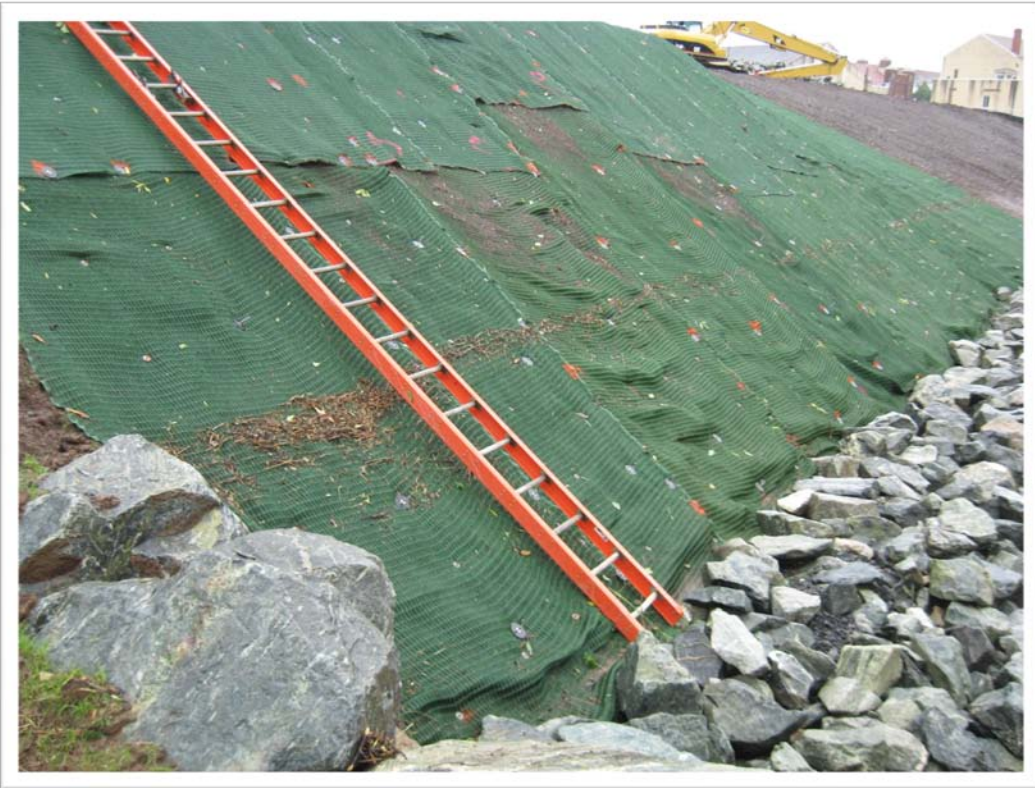
ArmorMax – Phase V Slope

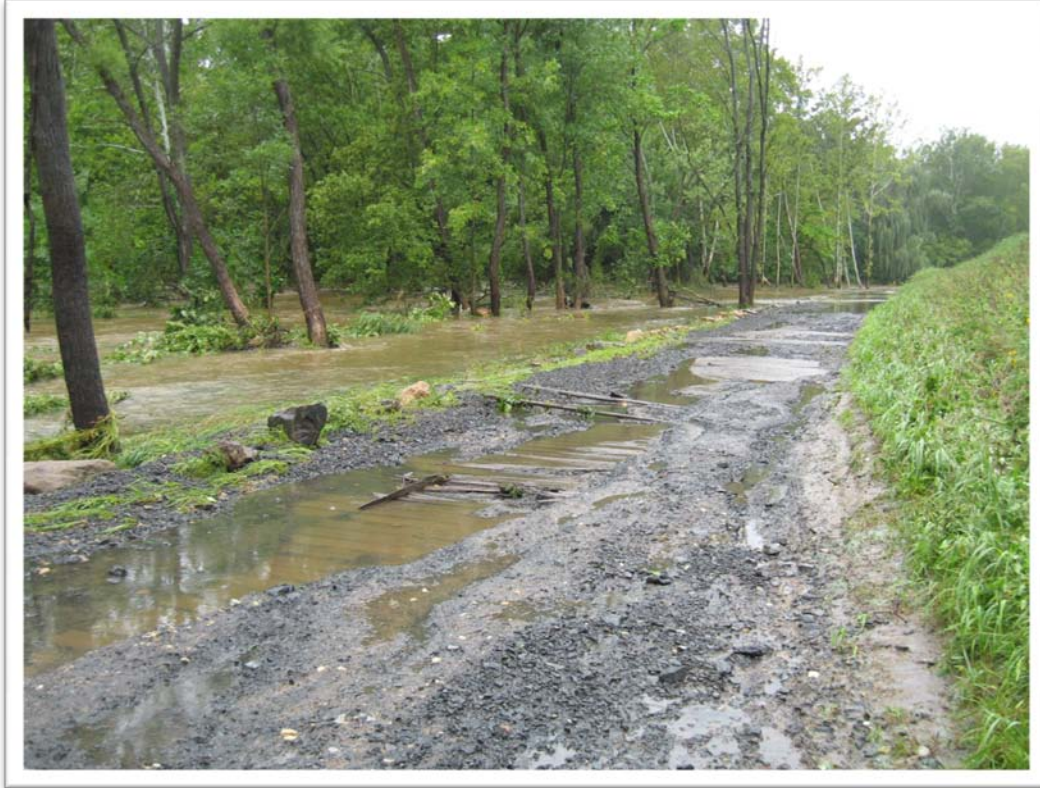
The access road (“boardwalk”) was under water; therefore, some of the gravel was washed away.

“Boardwalk” – by Phase III Slope

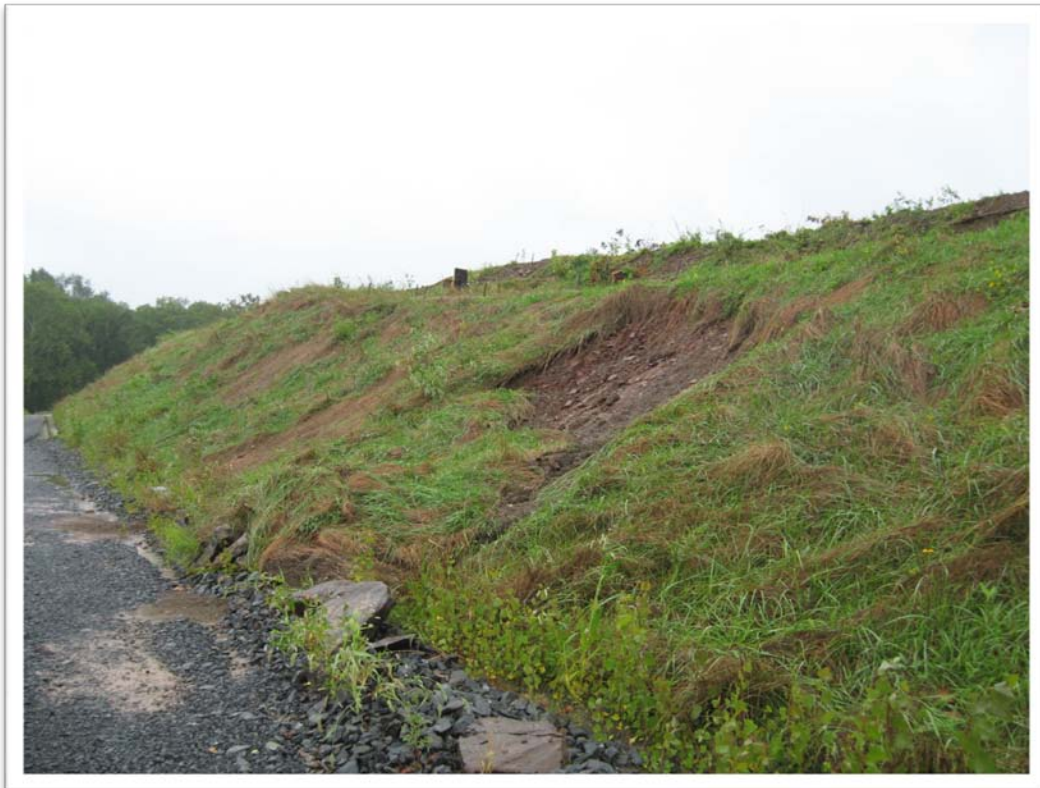
There was a mudslide along the pile slope by Tannery Run. That area was already vegetated; however, it was going to be graded to obtain a better slope.

Pile Slope by Tannery Run

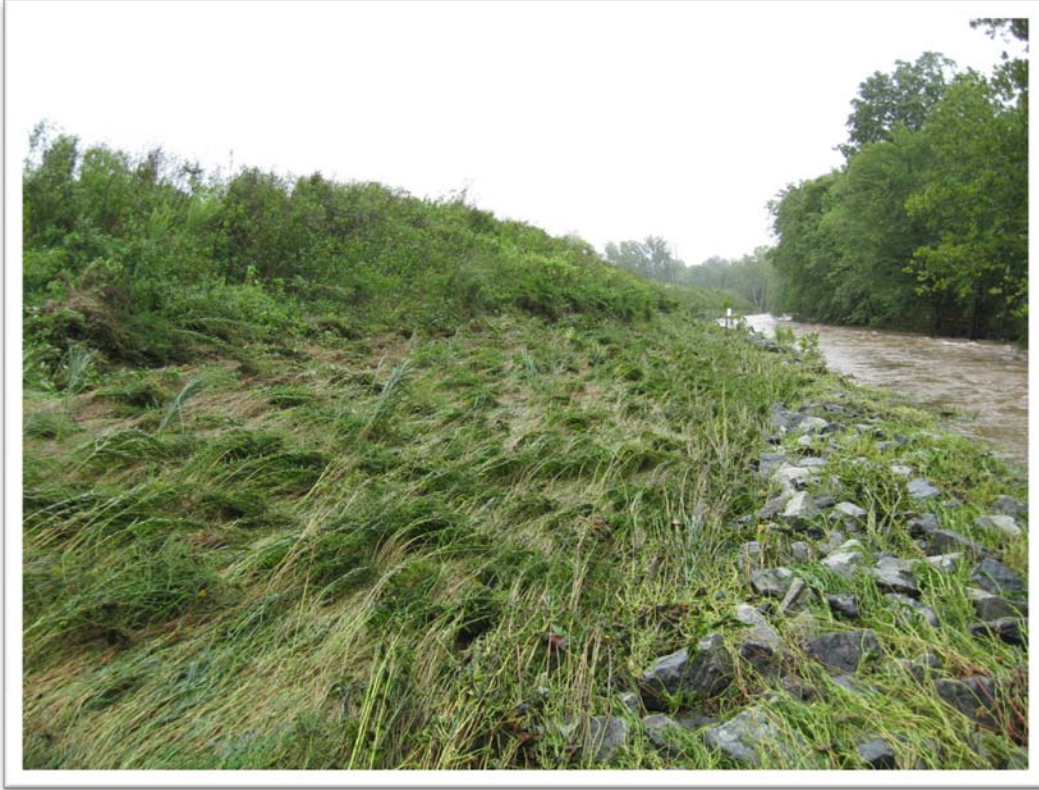
Although the water was about 4 to 5 feet over the riprap line and the vegetation on the lower part of the slope was down due to the flow, the slope itself seems to be intact. No erosion problems were noted.

Phase I Slope

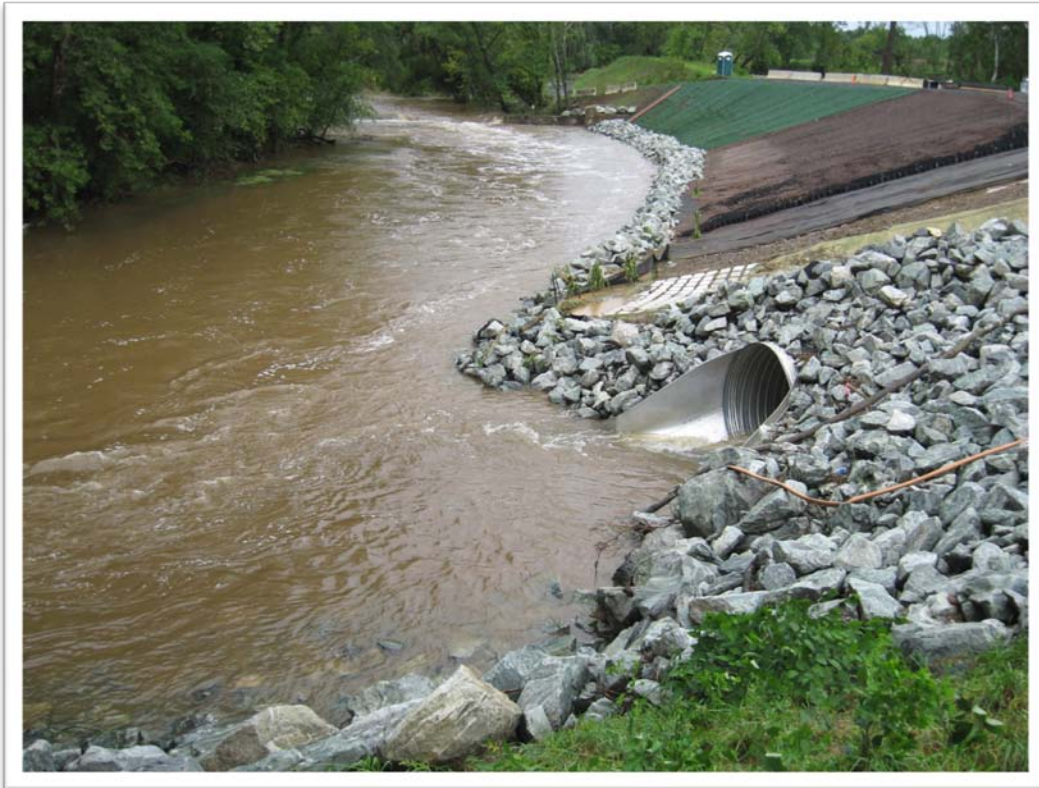
Confluence of Tannery Run and the Wissahickon Creek & view of the Phase V Slope
