Alternate Green Stream Bank Stabilization Methods

**Wissahickon Creek, Tannery Run and Rose Valley Creek
Bo-Rit Asbestos Site
Ambler, Pennsylvania**

Prepared for
**U.S. Environmental Protection Agency
Region III**

June 2008

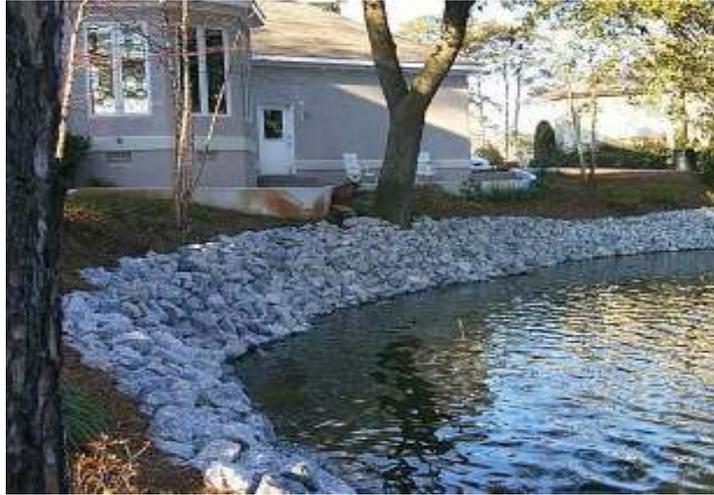
Riprap. Photo shows riprap above water line. Riprap above the waterline at Bo-Rit will be soil-choked and planted.

Toe: Since the toe will always be subject to shear stresses induced by water flow, a hardened structure is necessary. We recommend a riprap toe on the Wissahickon that extends up the bank for approximately 3 feet measured along the slope. This will require a geotextile overlain by 6 inches of bedding material and riprap having a layer thickness of approximately 12 to 18 inches. This protection will be placed on both sides of the Wissahickon. The right bank is uncontaminated and will therefore only receive a riprap toe to prevent any erosion. The protection will encroach into the stream several feet depending on the bank slope. Since the Wissahickon is approximately 30 feet wide and has a non-erodible rock bottom, this is not expected to have any serious effects on flow rate and flooding. However, before a design is finalized, hydraulic modeling should be completed to determine the effects due to the channel and overbank alterations.

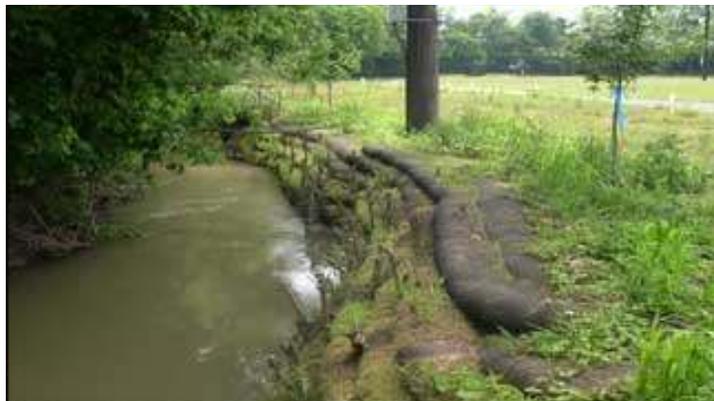
Erosion control tubes (Filtrexx photo)

Stacked Erosion Control Tubes; a.k.a., "Biologs" (degradable).

Wissahickon – Possible; Not recommended due to high velocities

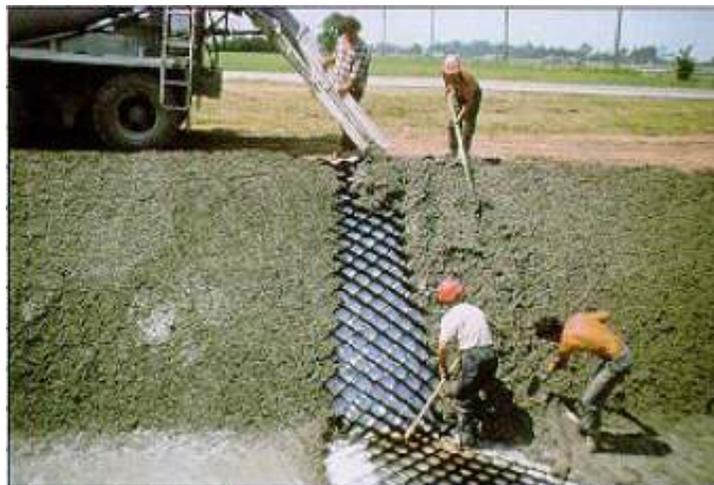
Geocells –cement filled

Geocells* – filled with stone or natural-looking cemented stone (non-degradable).

For the steeper slopes, we recommend lining the banks and channel with geocells. In the stream, it will be filled with stone or natural looking cemented stone. On the banks, the geocells will be filled with soil and vegetation. The geocells will also have to be anchored at the top of bank slopes using proprietary anchor systems. The anchor systems will be hidden from view, as the cables are internal to the geocells system and the anchors will be buried at the top of slope.

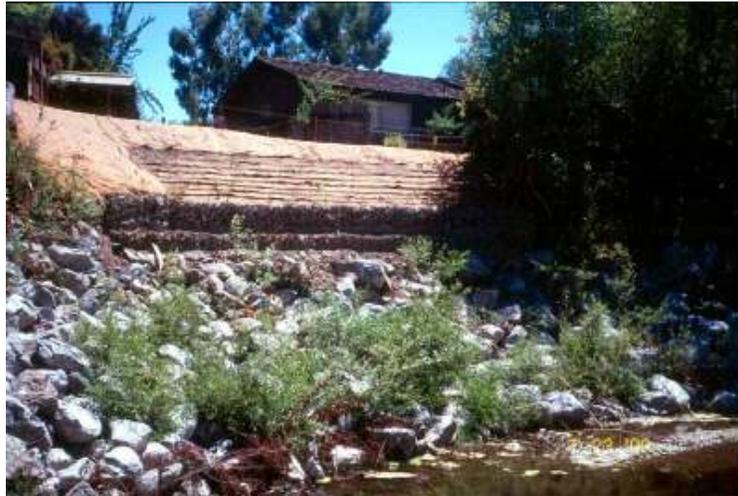
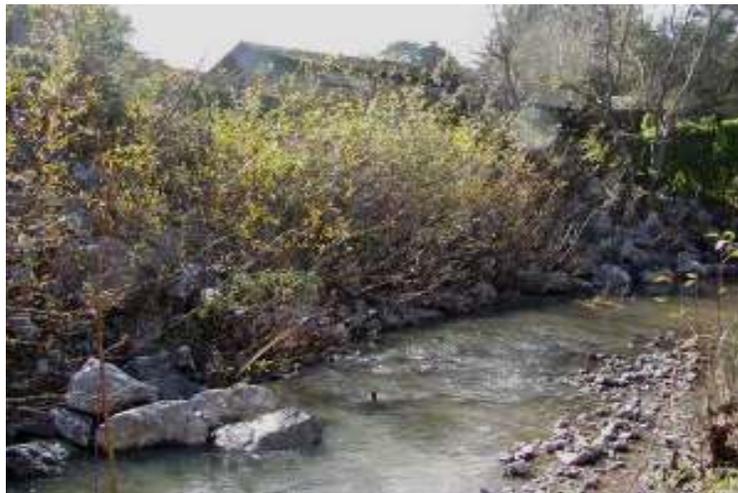
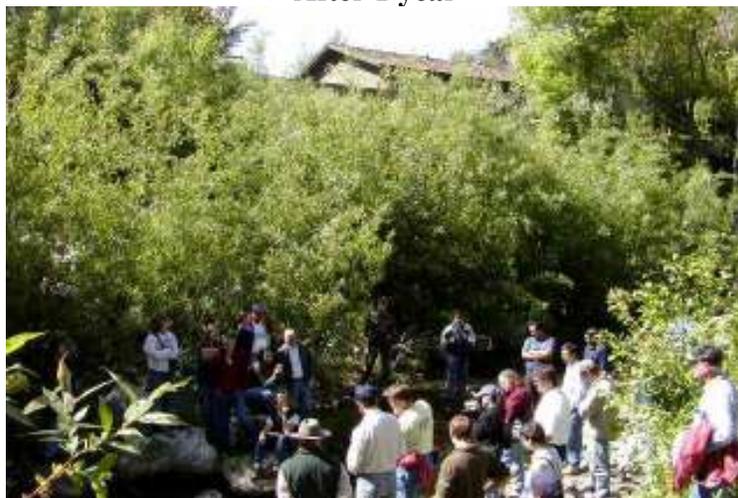
Soil Choked Riprap with plantings

After 1 year

After 2 years

Soil-choked Rip-rap with plantings (non-degradable).

Between toe and upland: The area above the toe will be dry under normal flows but will be submerged and subject to erosive forces under storm conditions. As such, the solution for this level should be a combination of an aesthetically pleasing “green” solution with a hardened structure for stability. For this level, we recommend a soil-choked riprap that extends up the bank approximately 4 feet above the riprap toe. Willows and a riverbank mix would be planted so that their root system would further stabilize the banks and also provide a green cover. Right bank protection above the riprap toe is not recommended.

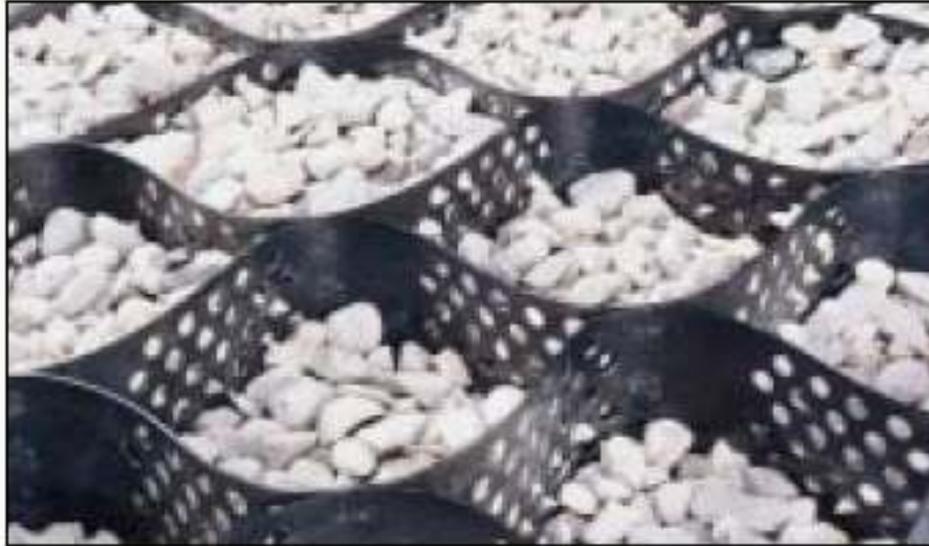
Confined Cellular System (CCS) – gravel filled
Soil will be placed on top of gravel

Geocells* – soil filled with plantings (non-degradable).

* Geocells are also known as Geoweb®, Confined Cellular System (CCS), etc.

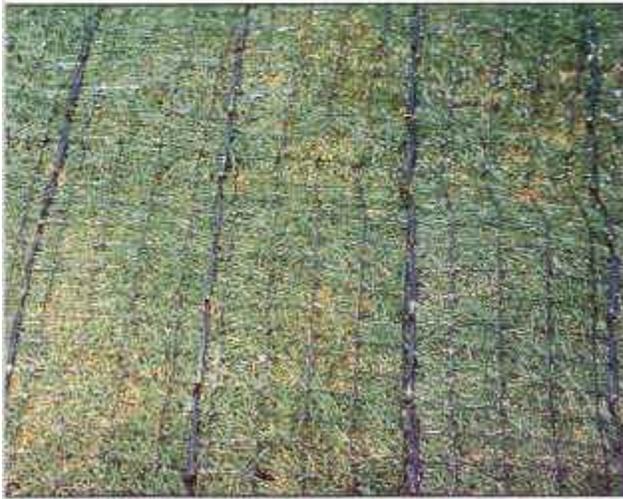
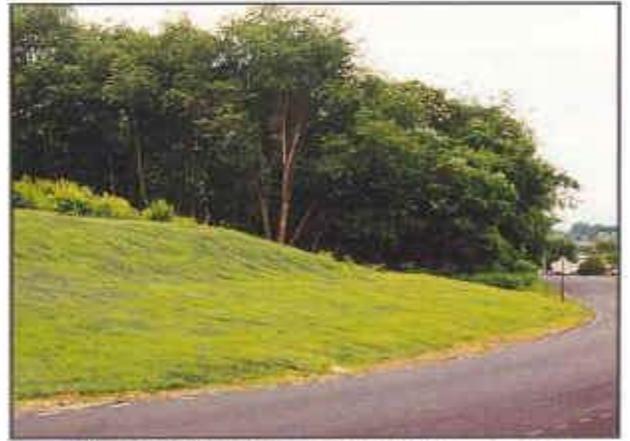
Slope Stabilization—Partially Vegetated
TerraGuard™ 45P

Turf Reinforcement Mat (TerraGuard Photo)

Soil Filled Turf Reinforcement Mat (TRM) (non-degradable).

Upland: EPA requested that our solution cover approximately 10 to 12 feet upslope on the banks. This area is expected to be submerged infrequently. FEMA’s Flood Insurance Study (2001) shows that the 10-year water surface is approximately 7 feet deep based on the channel center. Therefore, the recommended 3 feet of riprap and 4 feet of soil-choked riprap starting near the stream edge exceeds the 10-year water surface. No surveys were available to determine the elevation of the channel center compared to the channel edge. These heights should be adjusted based on surveys. Since this area will be dry most of the time, we recommend a soil-filled, turf reinforcement mat (TRM) be utilized in this area to stabilize the 12" of cover soil. Note that the 12" will be comprised of 8" of common clean fill overlain by 4" of topsoil. The TRM is approximately 1/2-inch thick and would be placed over the 4" of topsoil and then soil filled/seeded.

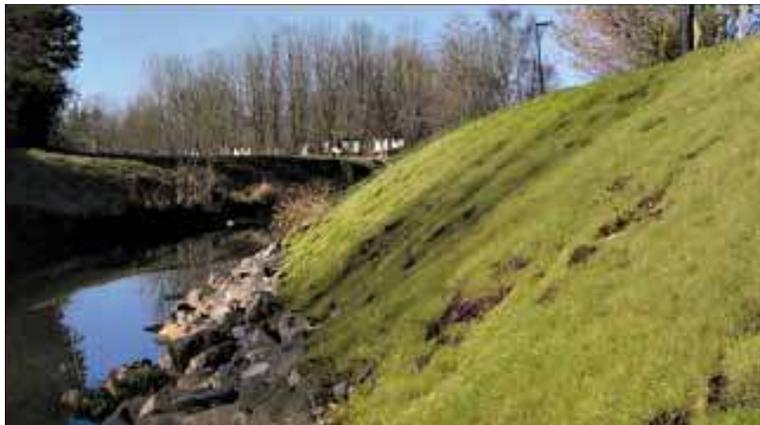
Eco Blanket (Filtrexx Photo)

Eco Blanket – pneumatically sprayed TRM alternative (degradable).

Wissahickon – Not recommended; May not be as durable as a TRM

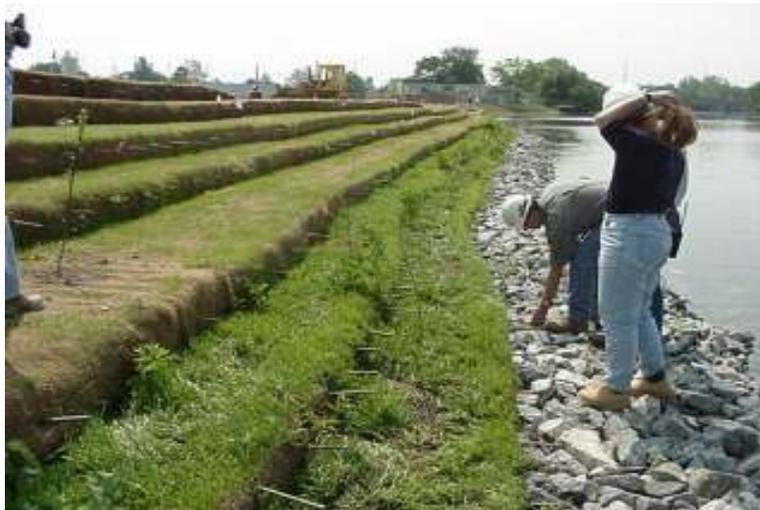
Coir Mat with Willow Plantings

Coir Mat (degradable).
